**WATER QUALITY MONITORING UPSTREAM AND DOWNSTREAM OF SMOLT PRODUCTION FACILITIES ON
THE UPPER DERWENT AND FLORENTINE RIVERS**

April 2019

Client: Environment Tasmania

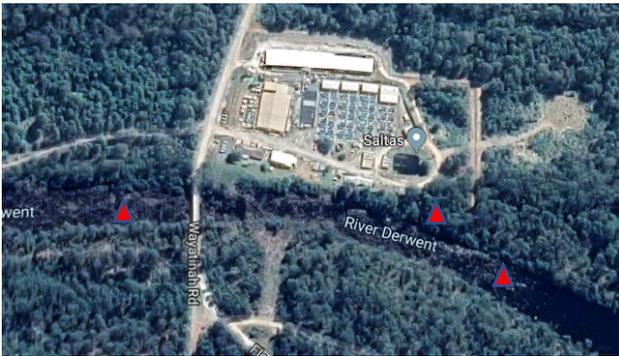
Approximate sample locations: Wayatinah

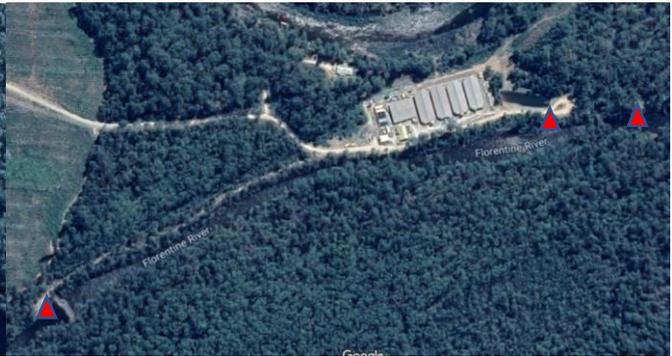
Approximate sample locations: Florentine

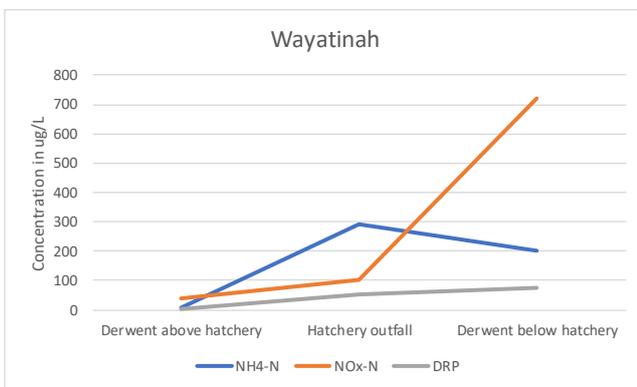
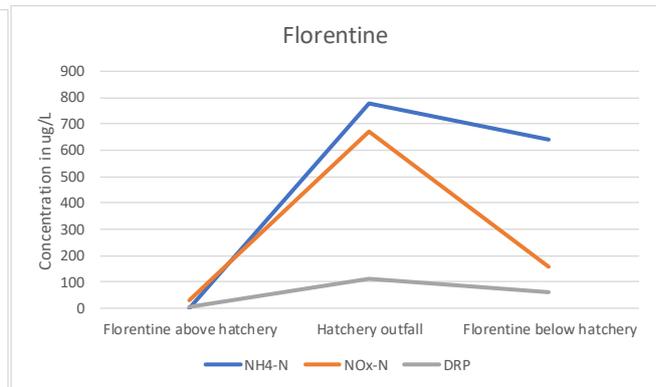
Concentrations of dissolved nutrients at sites sampled (to provide some context, Australia's national water quality guidelines for slightly disturbed ecosystems recommend a concentration of 15 ug/L for NOx-N and NH4-N, and 5 µg/L for DRP)

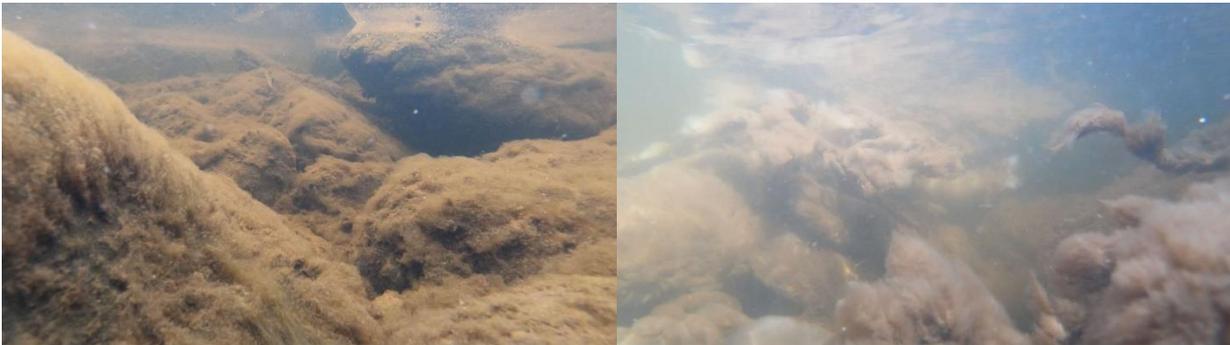
in the river downstream of the hatchery ranged from 5 to more than 128 times upstream levels. Significant levels of fouling were also observed on the rocks and river bed downstream. Coliform and E coli bacteria levels in the outfall were very high, and there was a strong odour and visible slick in the area.

Biofouling downstream of outfalls

- It is recommended that smolt production facilities located in the Derwent catchment either implement best management practices (e.g. full recirculation) or that smolt production be moved to facilities with modern wastewater treatment processes.
